## ST ERTH CHURCHYARD CROSS

### Introduction

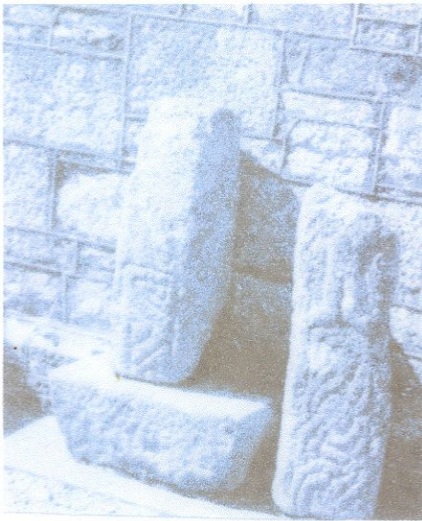
Fixed against the wall at the north-west corner of the south aisle are two pieces of a pre-Norman churchyard cross. The two pieces were found built into the wall of the church when it was restored in 1875. For over a hundred years they remained loose in the churchyard until June 1998, when they were brought into the church for preservation.

*Cross fragments prior to 1982*

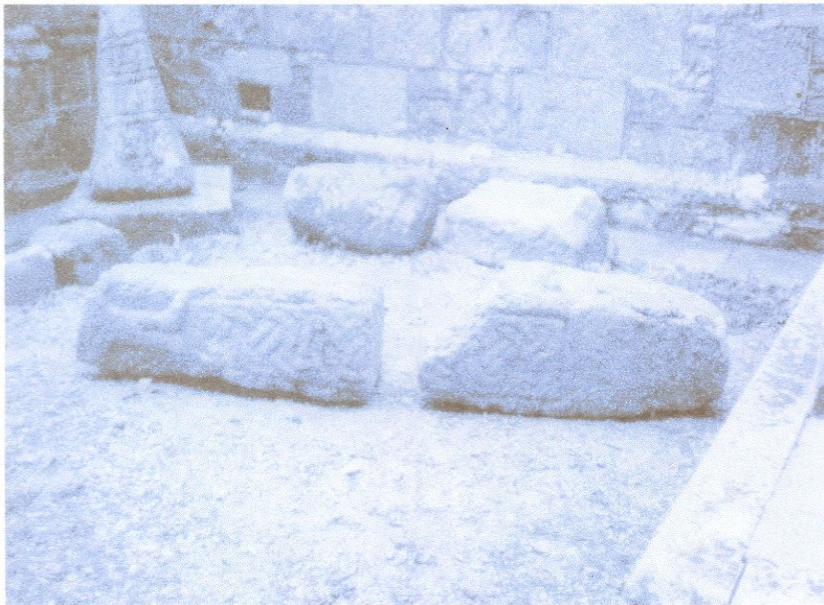
At the time, it must have been a striking fashionable monument - a real status symbol - but as the centuries wore on it became out-dated and eventually, probably in the 15th century, it was broken up and re-used as building stone when the church was being enlarged and reconstructed. There the pieces lay until the late 19th century when the church was being restored. The stones were removed from the wall and when seen and illustrated by the Cornish historian, A.G.Langdon, in his famous work on Old Cornish Crosses, they stood one on top of the other on a modern granite base, against the south aisle wall. At some time after this, the stones were placed side by side and remained so until about 1984 but for the last fourteen years, until their restoration in June 1998, they lay loose on the ground by the south porch.

*Cross fragments in 1995*

The conservation work was carried out in June 1998 by Sue and Lawrence Kelland, stonework conservators, with help from Andrew Langdon, local expert on crosses. The first stage involved strengthening the floor to take the weight of the cross fragments. An area of floorboard was cut and the void filled with concrete. On top of this a new granite base was set. Then the lower portion of the cross-shaft was set up on the base-stone and fixed to the wall with stainless steel clamps. The upper section was lifted into place with scaffold tower, block and tackle, and supported above the lower on a stainless steel bracket. This too was held in place by means of a stainless steel clamp. Finally, the gap between the two fragments was filled with a lime-mortar, to visually unite the two halves and to add stability to the final monument.
